DEPARTMENT OF TRANSPORTATION

Contract #: 04-0120F4Cty: SF/ALA Rte: 80 PM: 13.2/13.9File #: 1.28**WELDING INSPECTION REPORT****Resident Engineer:** Casey, William**Address:** 333 Burma Road**City:** Oakland, CA 94607**Report No:** WIR-028080**Date Inspected:** 30-Jul-2012**Project Name:** SAS Superstructure**OSM Arrival Time:** 700**Prime Contractor:** American Bridge/Fluor Enterprises, a JV**OSM Departure Time:** 1930**Contractor:** American Bridge/Fluor Enterprises, a JV**Location:** jobsite**CWI Name:** Steve Jensen/William Sherwood**CWI Present:** Yes No**Inspected CWI report:** Yes No N/A**Rod Oven in Use:** Yes No N/A**Electrode to specification:** Yes No N/A**Weld Procedures Followed:** Yes No N/A**Qualified Welders:** Yes No N/A**Verified Joint Fit-up:** Yes No N/A**Approved Drawings:** Yes No N/A**Approved WPS:** Yes No N/A**Delayed / Cancelled:** Yes No N/A**Bridge No:** 34-0006**Component:** OBG**Summary of Items Observed:**

13W/14W Drop-In

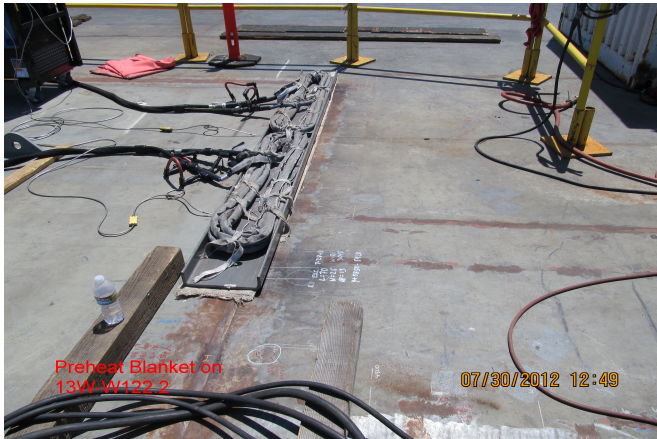
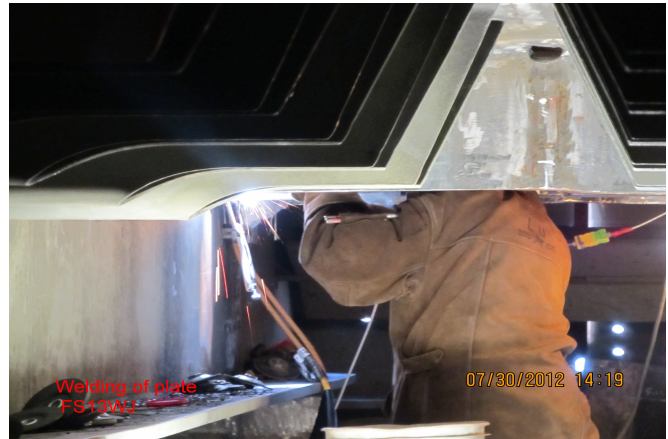
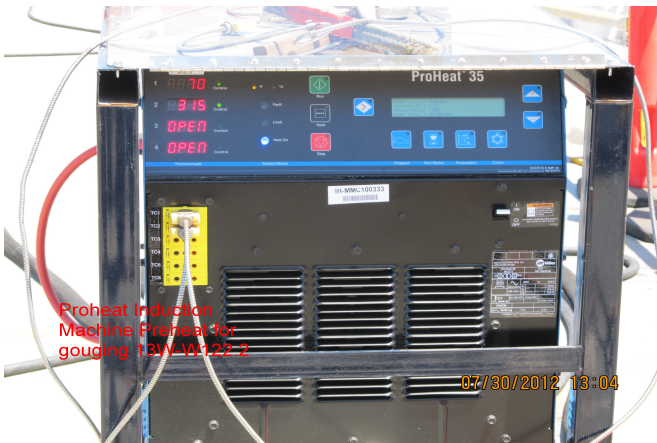
This QAI observed the fitting of plate FS-13-WJ to the corresponding stiffener. After the initial fit-up an 11mm gap existed between plate FS-13-WJ and the corresponding stiffener. This QAI reported the non-compliance to American Bridge Quality Control Inspector Steve Jensen, and the issue was resolved promptly. The gap between the plates just prior to welding was 2mm. Strong backs were used to keep the plates in position until enough weld had been deposited.

This QAI observed Welder Xiao Juan Wan (ID#9677) using a rosebud torch to preheat Stiffeners 12W/13W LS-7, and LS-8 to a QC recorded, QA verified temperature of 250F. Preheat temperature was measured using a Tempil Stick. This QAI noted QC Tony Sherwood recording preheat temperature whenever there was a stop in work.

After fitting operations and the proper preheat temperature was achieved, Xiao Hua Luo (ID#1291) began welding the plates together utilizing the Shield Metal Arc Welding Process to the parameters in the Approved Welding Procedure Specification for the 3G, and 4G position.

This QAI witnessed induction heating blankets positioned above weld 13W-W122.2 and a preheat temperature of 325F maintained for most of the afternoon, but no work was performed.

Rick Clayborn began the process of grinding the B side of weld W13-W2.1 flush, in preparation for inspection and testing. This QAI performed a visual inspection and found that the ground portion of the weld met the ground flush requirements of The American Welding Society AWS D1.5-02. Grinding is not complete on the B side of weld.
